# Navajo Abandoned Uranium Mine Site Screen Report

## Section 23 AUM Site

**Weston Solutions, Inc.**

**May 2009**

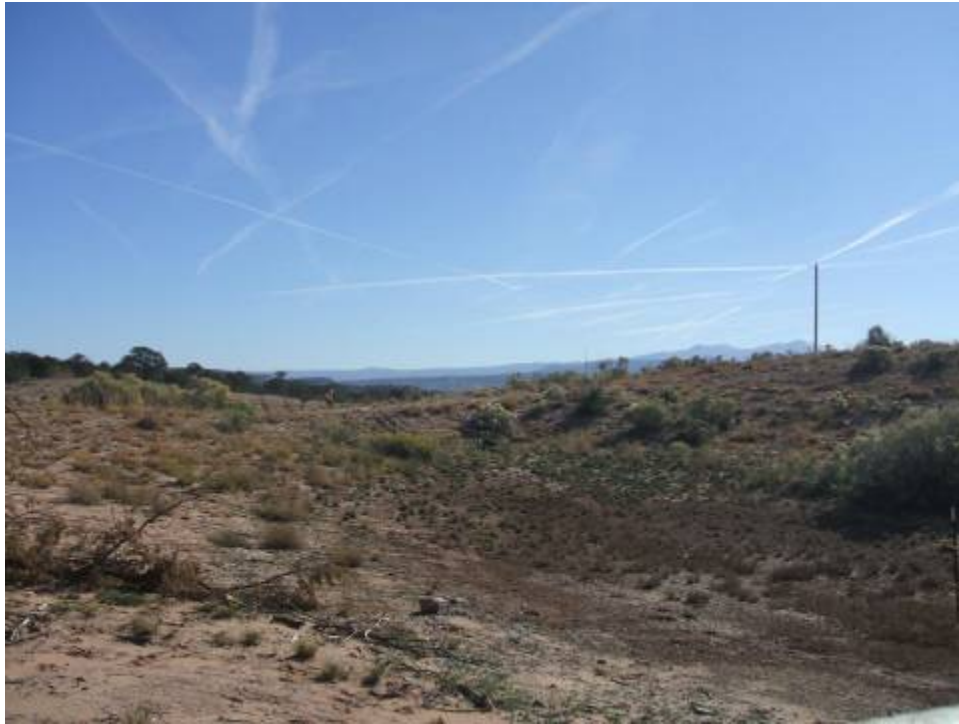
Photo 1. Section 23 mine site, eastern area, towards the east

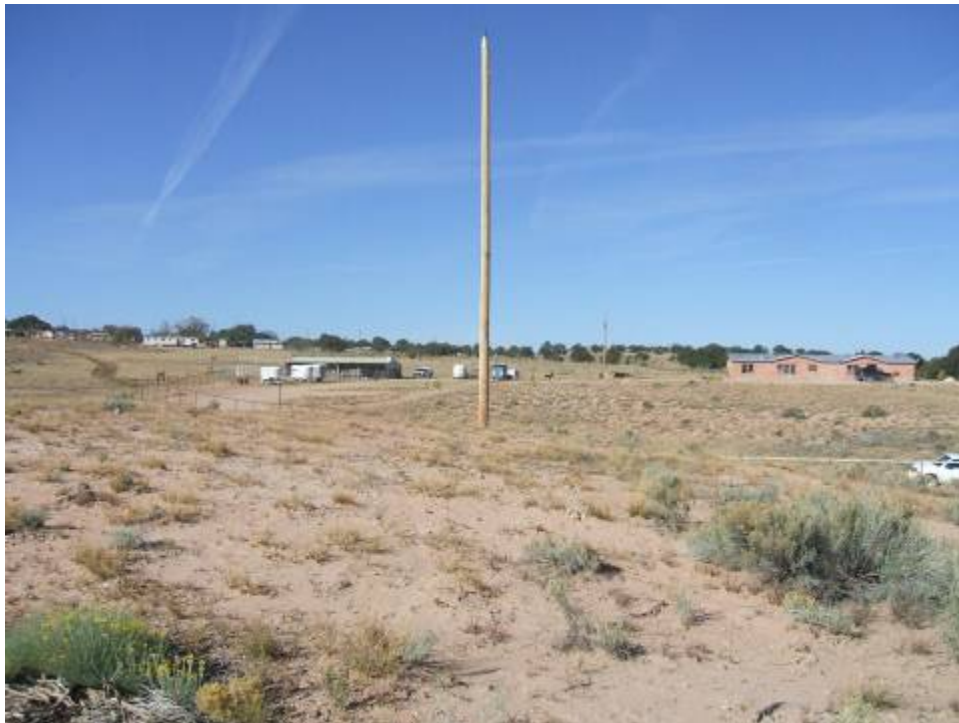
**0 to 200 feet:** 1 house is located within the north-central portion of the site. the house has been recently constructed, set on excavated cover material. Water is brought in from an outside source and stored in an underground poly-tank.

- The onsite house was measured at gamma radiation level upto 327,456 counts per minute (cpm)
- The levels near the trailer homes were found to be less than two-times background levels.

Photo 2. Section 23 mine site, house compound located onsite, towards the west

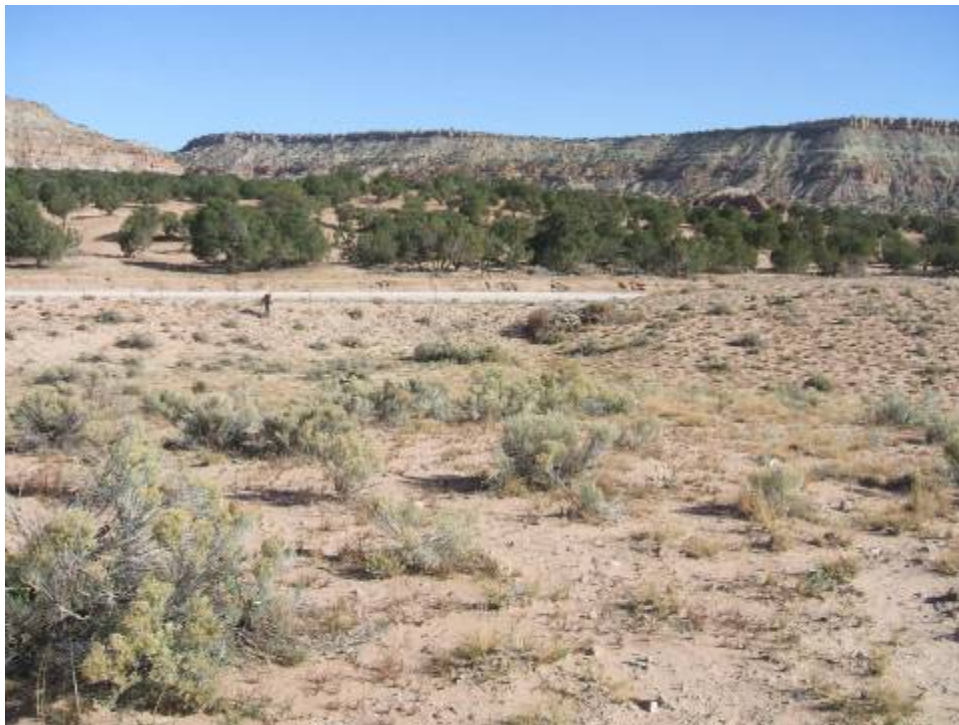
Photo 3. Section 23 mine site, western area, towards the west

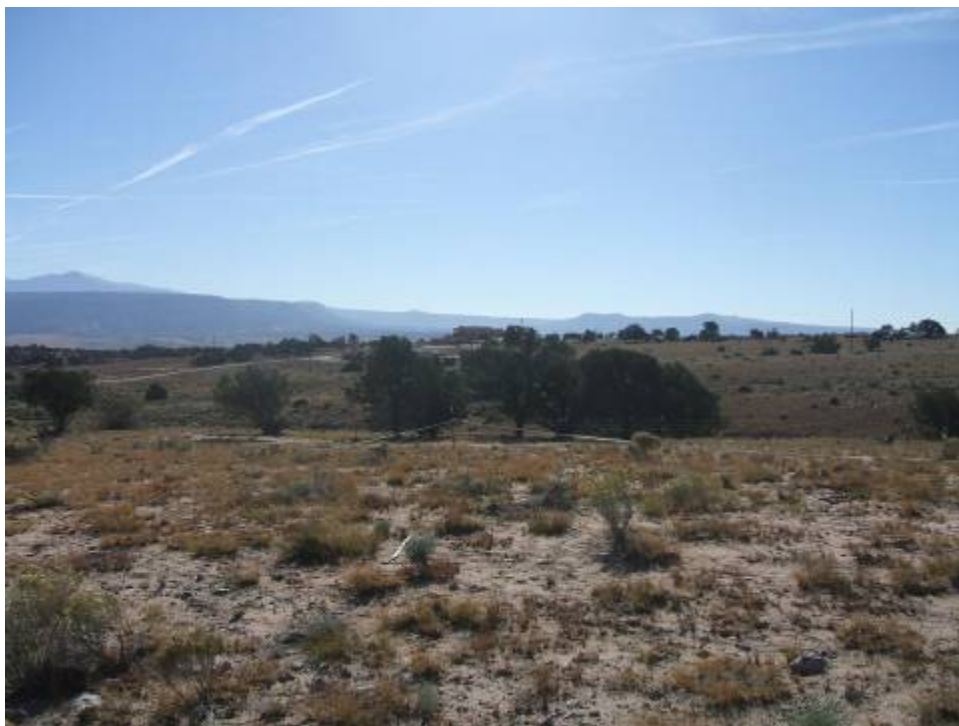
Photo 4. Section 23 mine site, western area, towards the south

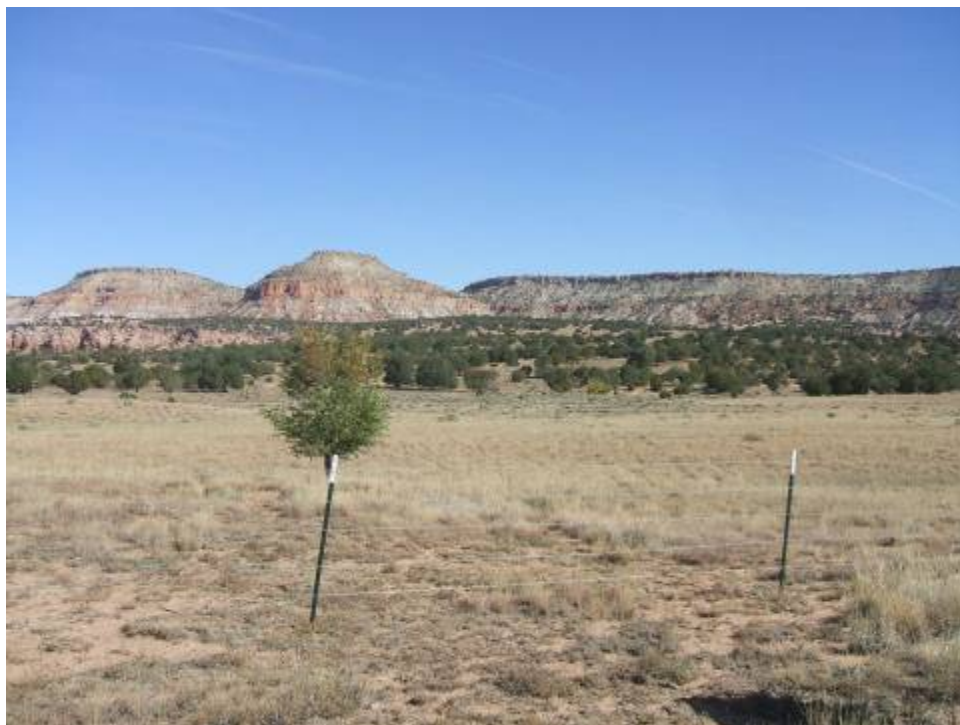
Reclamation status of the mine site is currently unknown. Local residents stated that several open pits had been filled in the western portion of the site, and the resident of the onsite house claimed that the house was built on excavated cover material. No adits or other mine features were observed during the site visit.

Photo 5. Section 23 mine site, former open pit in the western area, towards the north

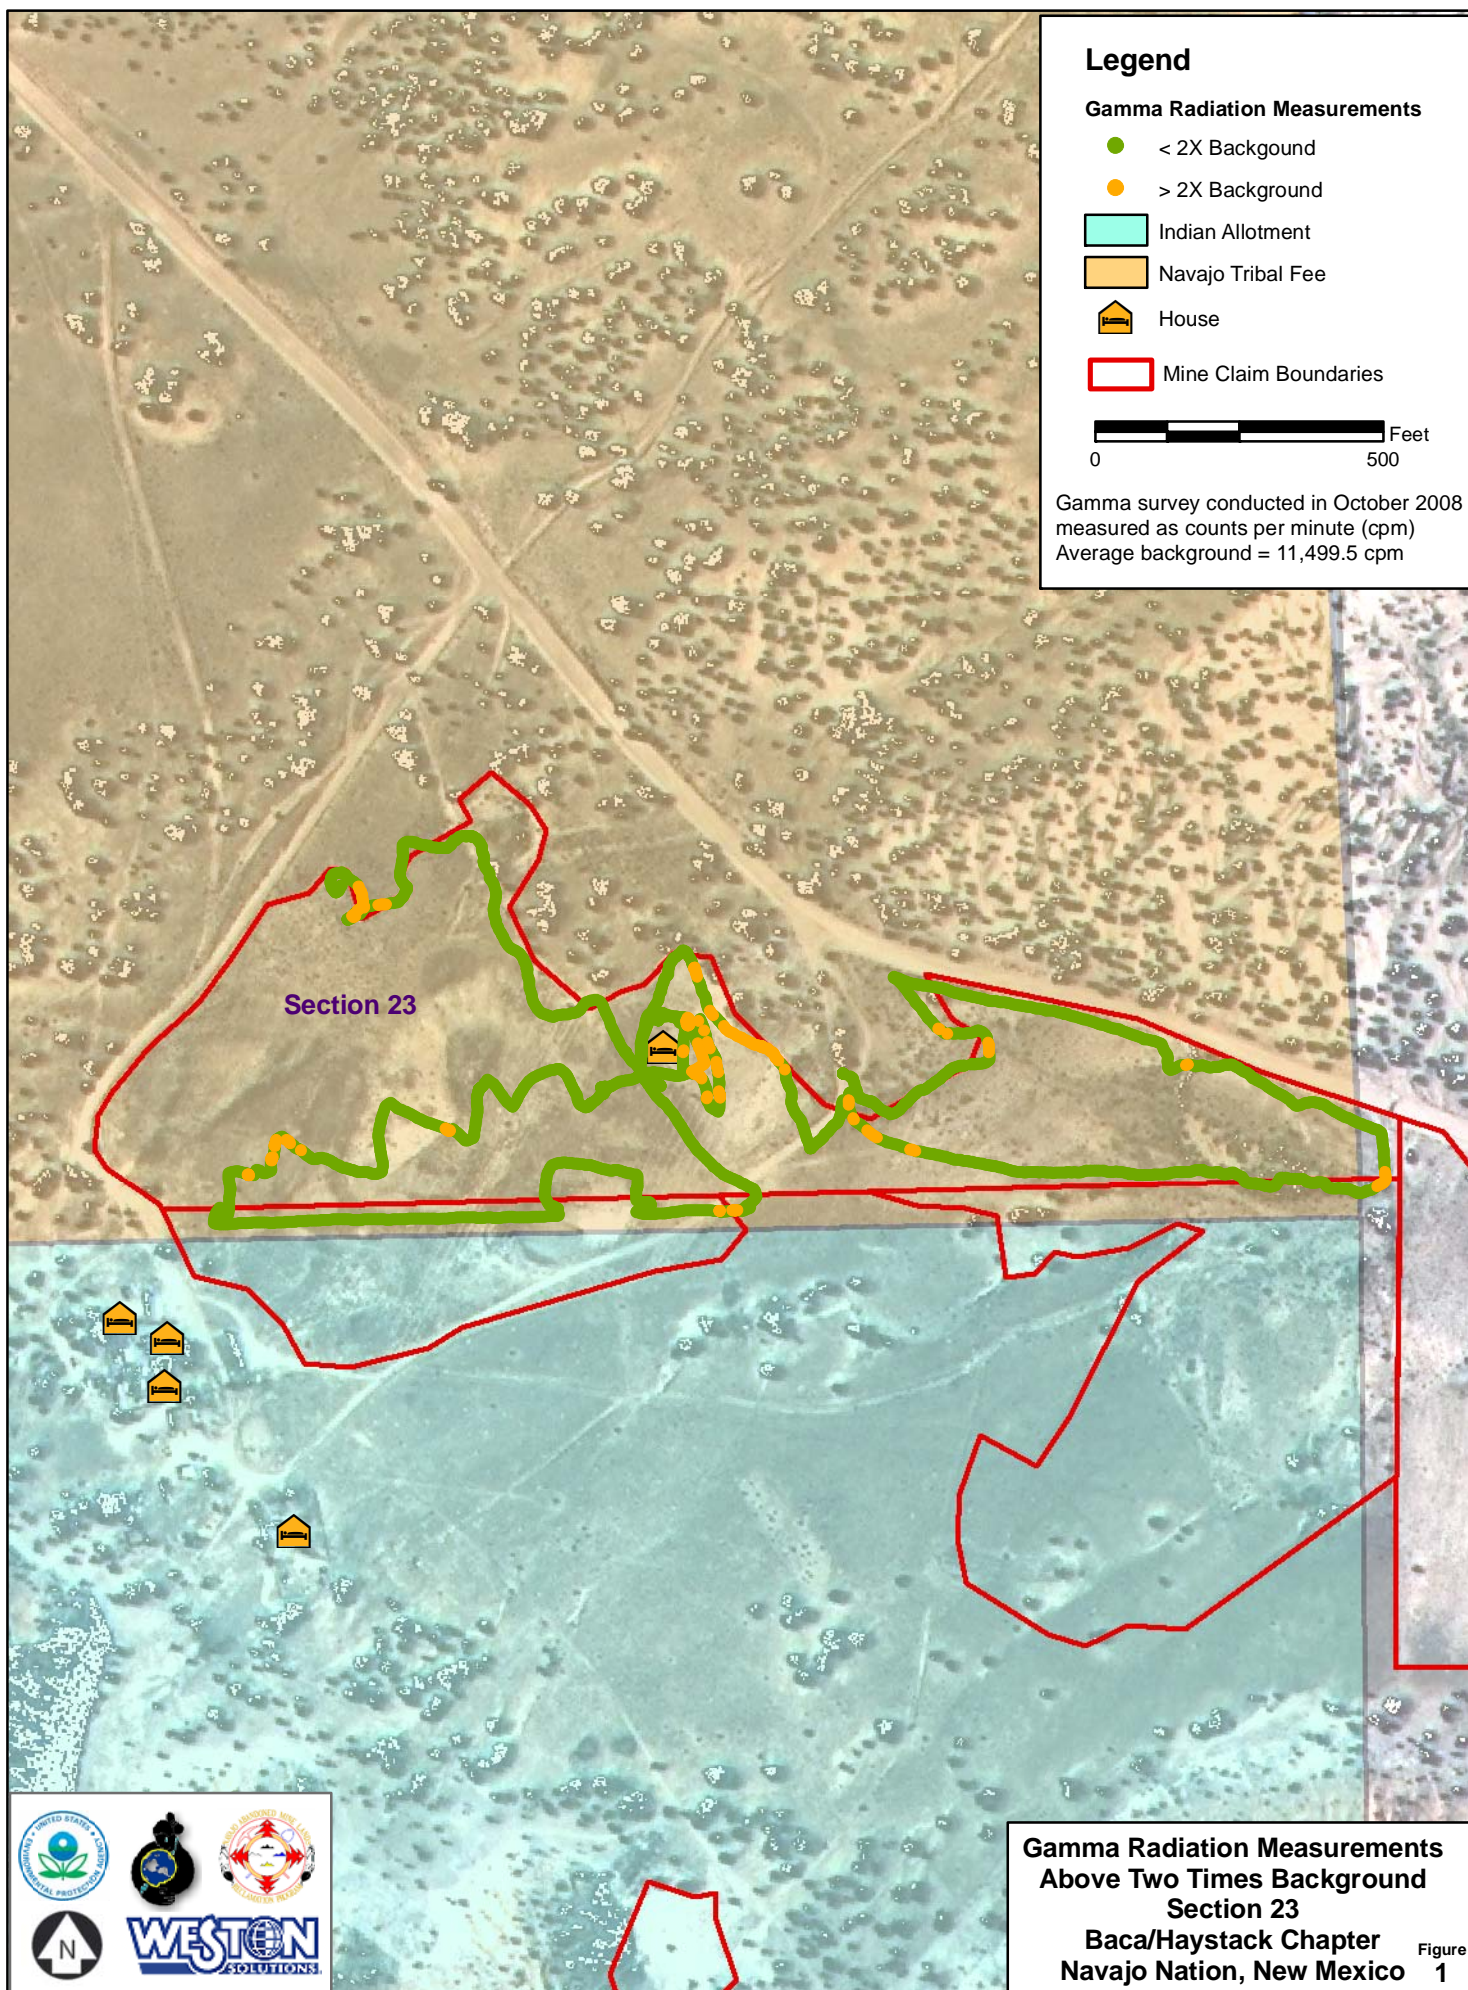
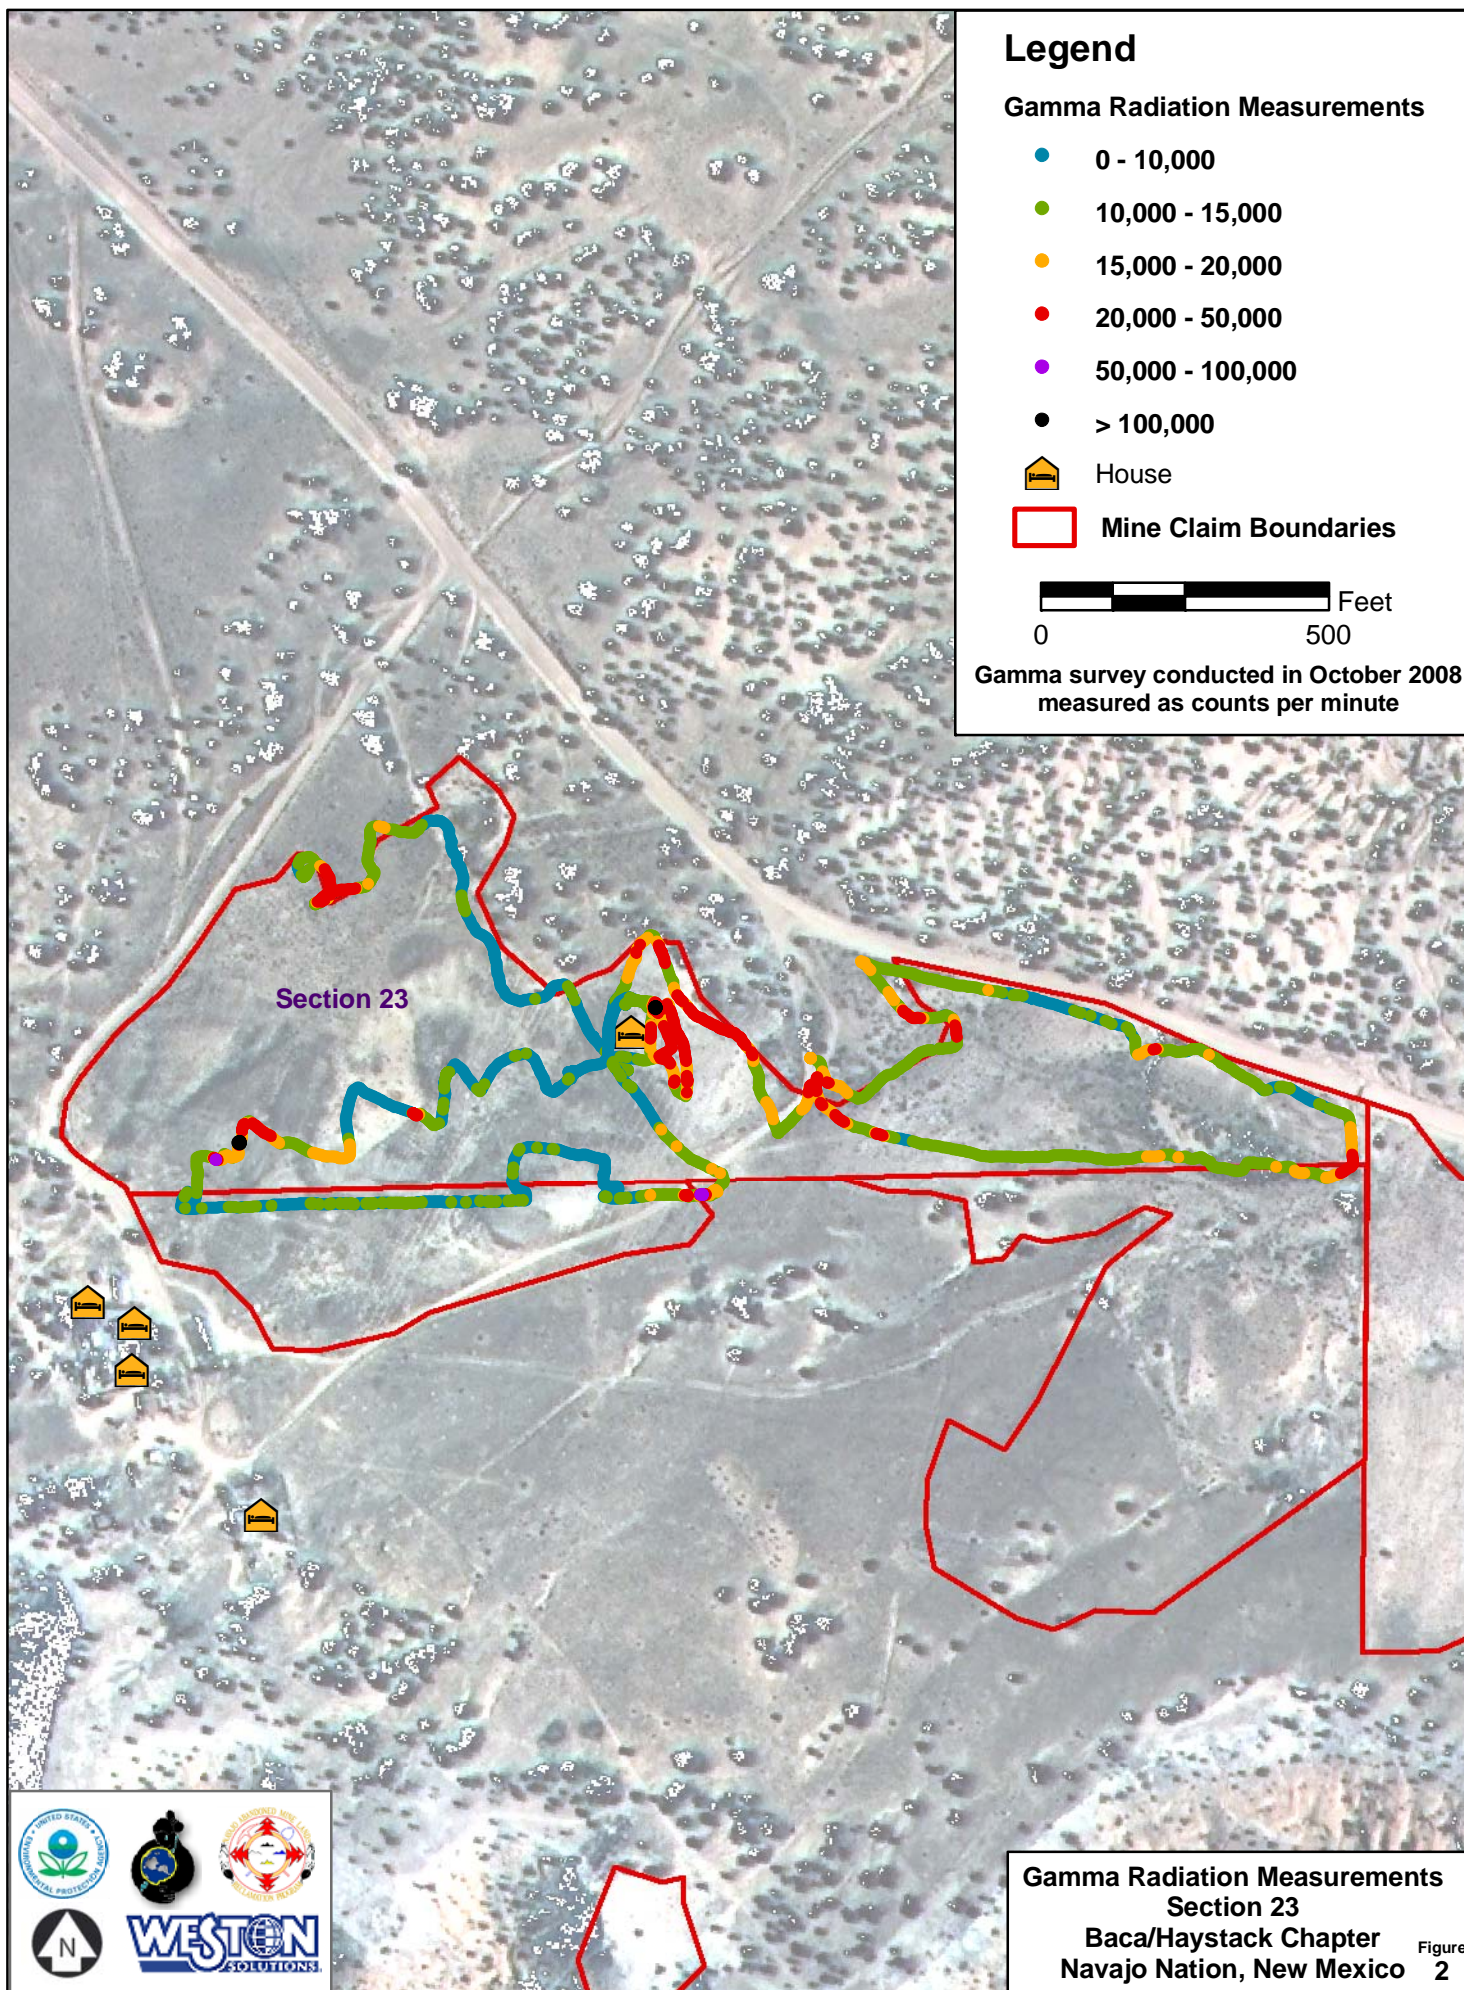
A total of 3,315 gamma radiation measurements were collected from mine sites, ranging from 5,802 cpm to 327,456 cpm. Measurements were found at their highest near the onsite house. The measurements are represented in Figures 1 and 2.
